**NASA CR-159739
EDR 10085**

PLASMA-SPRAYED DUAL DENSITY CERAMIC TURBINE SEAL SYSTEM

FINAL REPORT

**DETROIT DIESEL ALLISON
DIVISION GENERAL MOTORS CORPORATION
INDIANAPOLIS, INDIANA 46206**

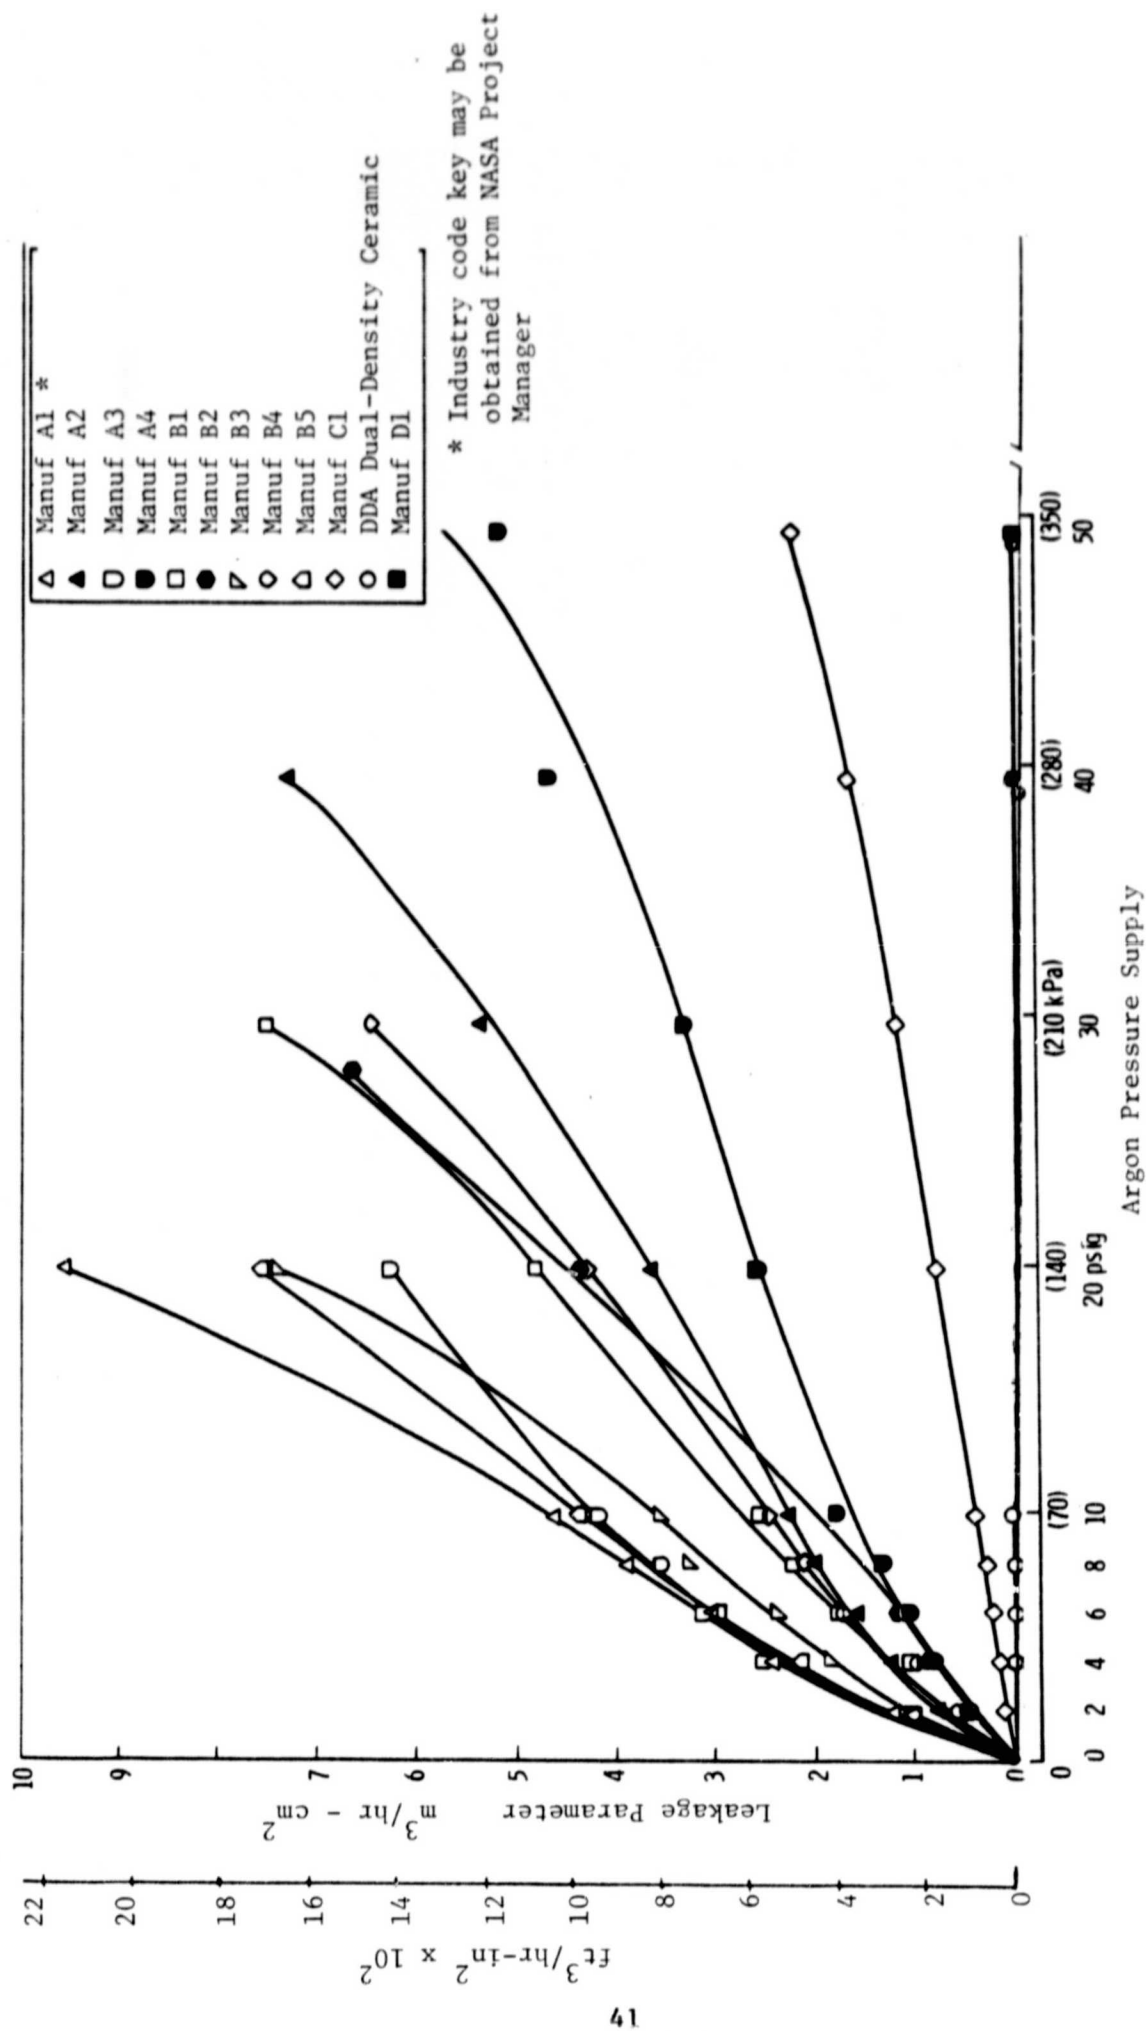
Figure 18 Abradable Seal Material Permeability

Gas flow permeability for each polyester-filled coating system was checked in accordance with the procedure previously described. Static input pressures up to 344.5 KPag (50 psig) were applied with zero leakage noted. These results are compared with the results obtained for conventional abradable materials in Figure 18.

Permeability for each coating was checked to 344.5 KPag (50 psig) with zero leakage noted. Both polyester- and cenosphere-filled systems displayed superior leakage characteristics in comparison with more common abradable materials, as shown in Figure 18.

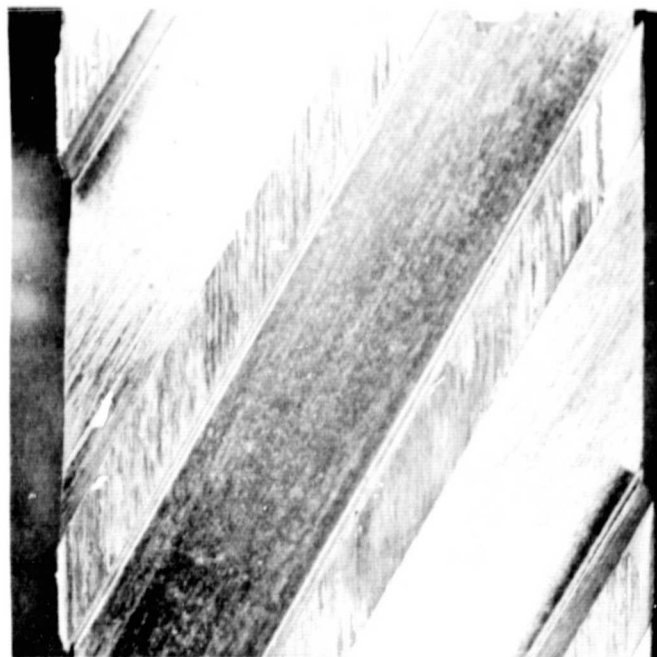
Blade track wear scar

Incursion rate:
.0025 cm/sec
(.001 in/sec)

Blade Tip speed:
229 m/sec
(750 ft/sec)

Blade tip condition

Figure 19 Slow incursion rate abrasability test results for specimen configuration I-C Magn: 5X

Figures 19 through 21 are the results of the slow incursion rate abrasability tests on the cenosphere-filled coating systems. These coatings were generally characterized by a very audible telegraphing of the rotating blade tip contacting the abradable surface. The presence of severe glazing and thermal cracking in the surface of the abradable layer during the slow incursion rate tests suggested a more rapid incursion rate could result in possible damage to the test rig and were therefore deleted from the test program. In all instances, the wear scar appeared to be glassy in nature and layered above the surface of the wear path. The layering appears to start at the entrance to the rub zone and builds in thickness as the blade path exits the material. The blade tips all exhibit heavy burnishing and some scoring and it is likely that some glazed material adhered to the blade tips, thereby preventing an accurate measure of blade tip loss. This loss as best determined,

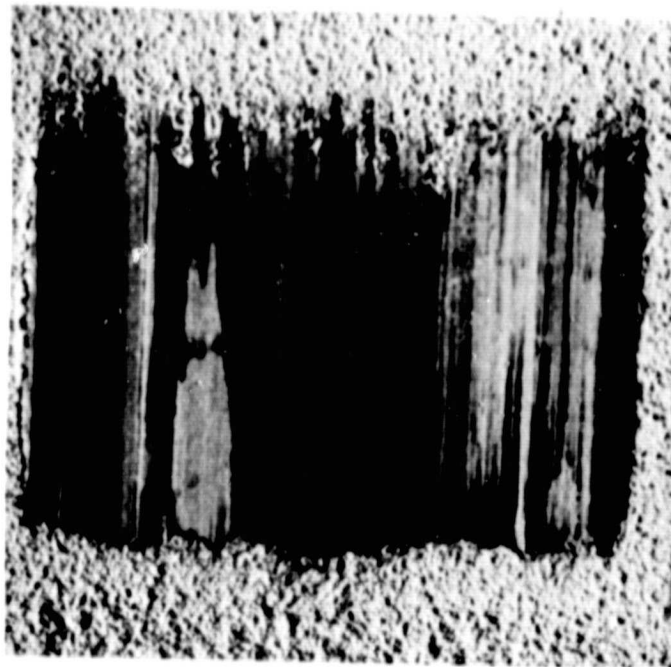
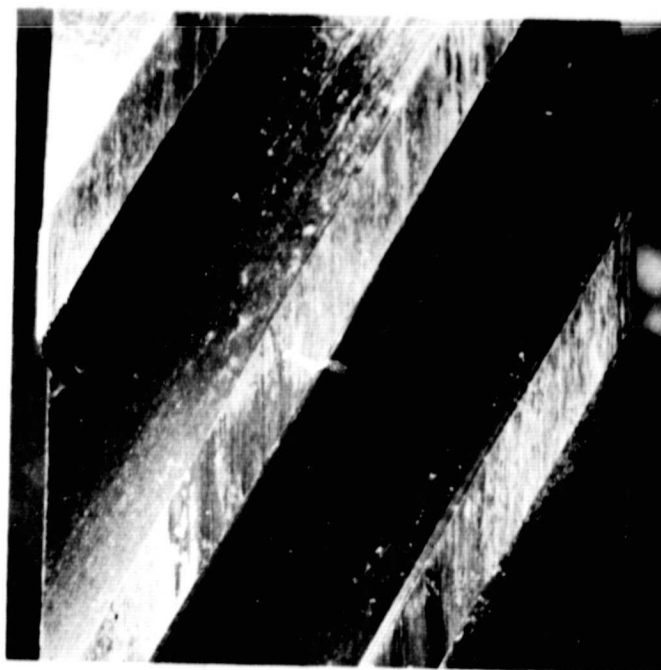
Blade track wear scar

Incursion rate:
.0025 cm/sec
(.001 in/sec)

Blade tip speed:
229 m/sec
(750 ft/sec)

Blade tip condition

Figure 20 Slow incursion rate abrasability test results for specimen configuration II-C Magn: 5X

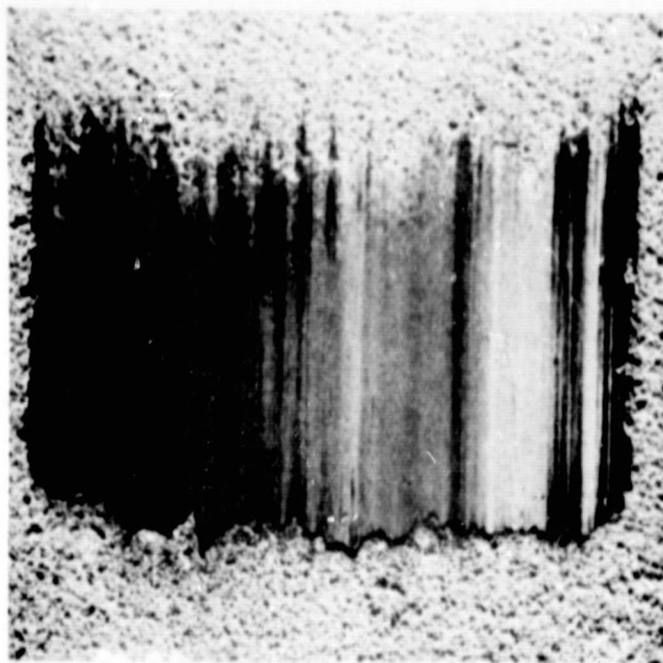
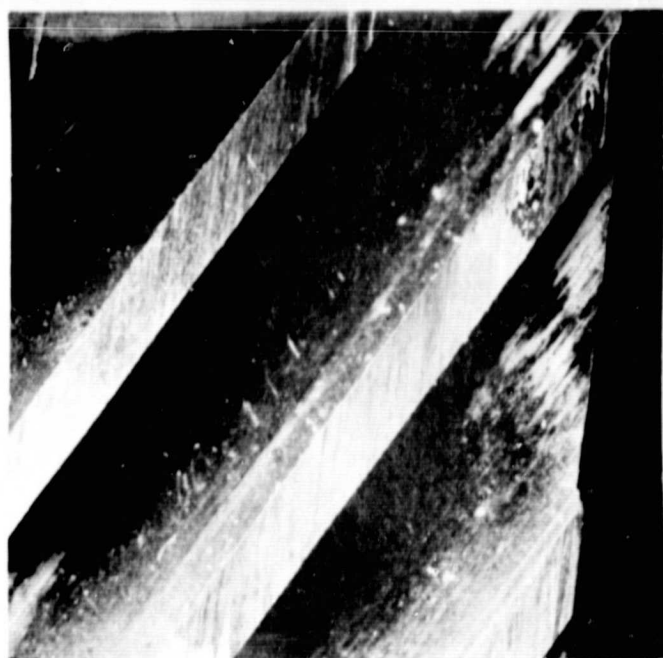
Blade track wear scar

Incursion rate:
.0025 cm/sec
(.001 in/sec)

Blade tip speed:
229 m/sec
(750 ft/sec)

Blade tip condition

Slow incursion rate abrasability test results for specimen
configuration III-C Magn: 5X

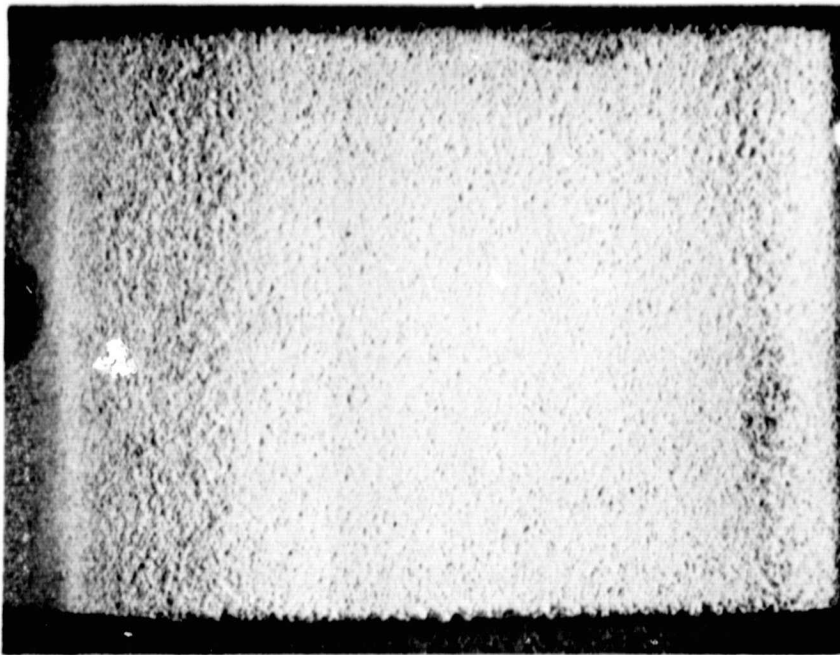
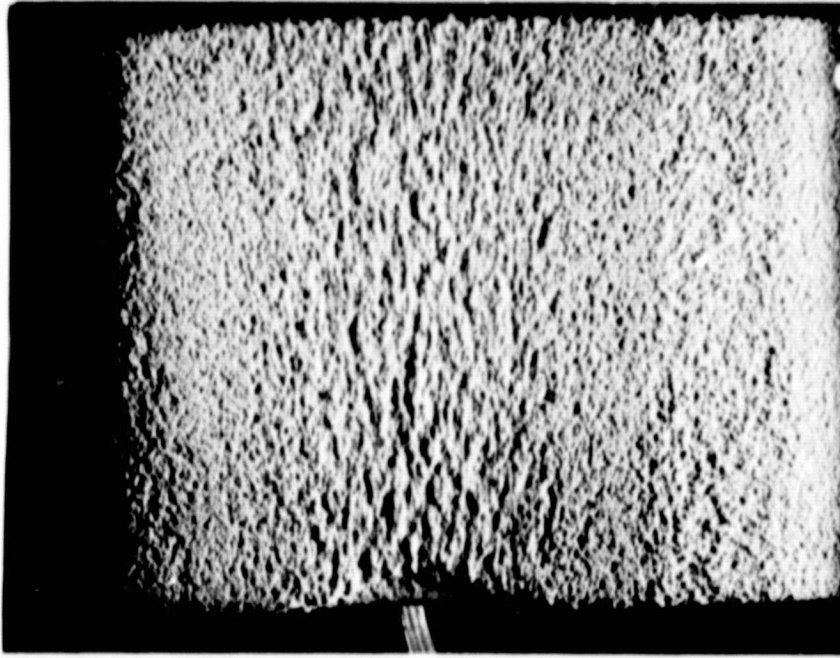
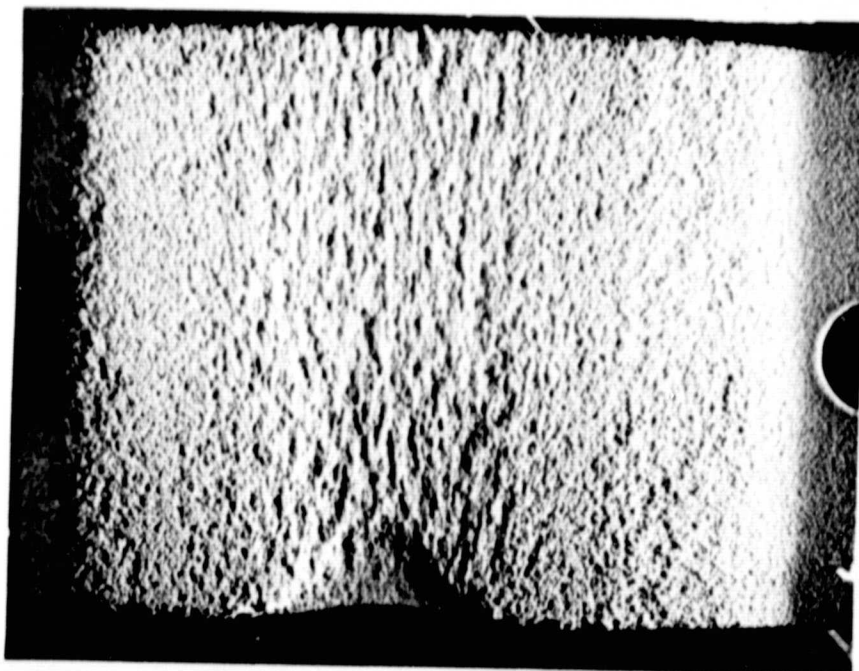
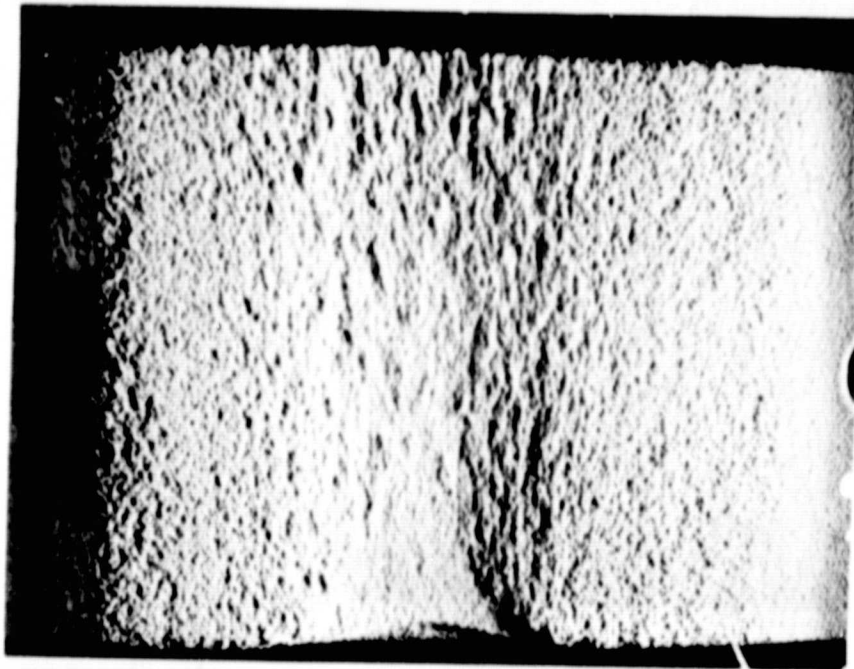
a. As machined

b. 30 min. exposure (9.3 gm abrasive)

Figure 22 Development of accelerated erosion wear scar with time for coating system I-C Magn: 3X

c. 60 min. exposure (22.8 gm abrasive)

d. 120 min. exposure (50.3 gm abrasive)

Development of accelerated erosion wear scar with time for coating system I-C
Magn: 3X

Erosion test results of the cenosphere-filled systems are shown in Figures 22 through 24. No evidence of layering, as was observed in the I-P system, was present in any of the cenosphere-filled coatings. Erosion resistance of the cenosphere-filled systems was significantly improved over the polyester-filled systems. The specific erosion resistances, as plotted in Figure 17, of the three cenosphere filled systems were very similar in erosive performance, as could be expected when comparing the final composition listed in Table IV.

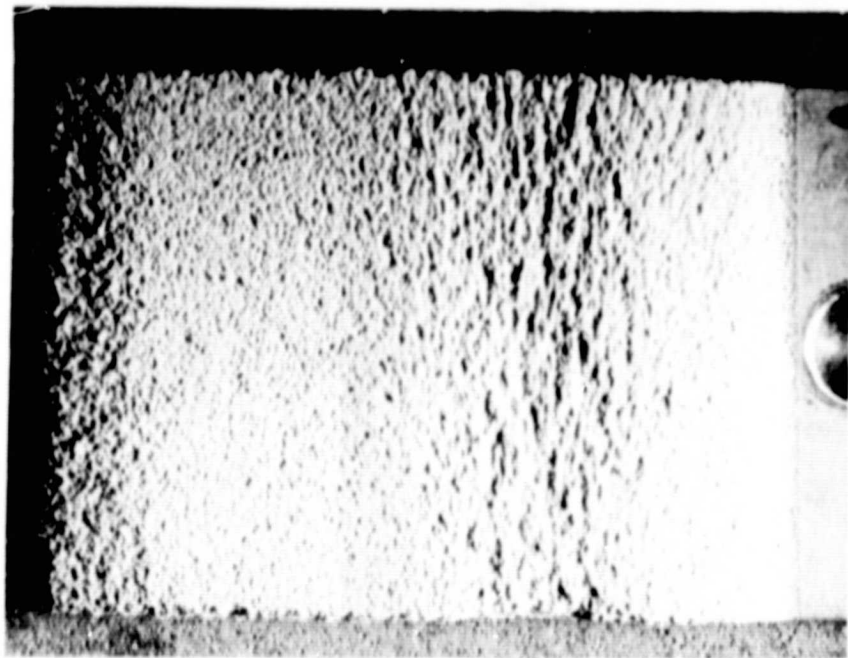
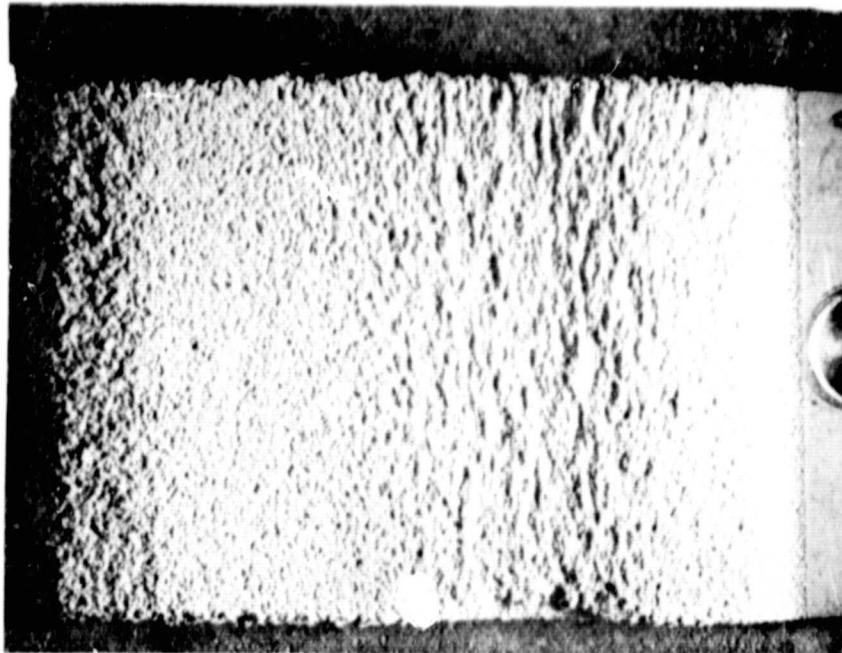
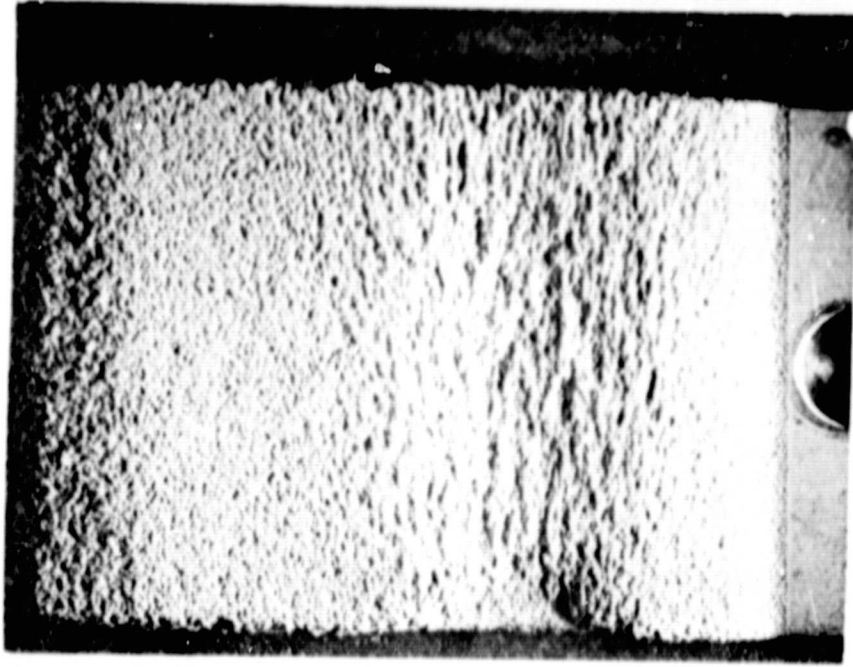
a. As machined

b. 30 min. exposure (7.1 gm abrasive)

Figure 23 Development of accelerated erosion wear scar with time for coating system II-C Magn: 3X

c. 60 min. exposure (17.0 gm abrasive)

d. 120 min. exposure (42.2 gm abrasive)

Figure 23 (cont.) Development of accelerated erosion wear scar with time for coating system II-C Magn: 3X

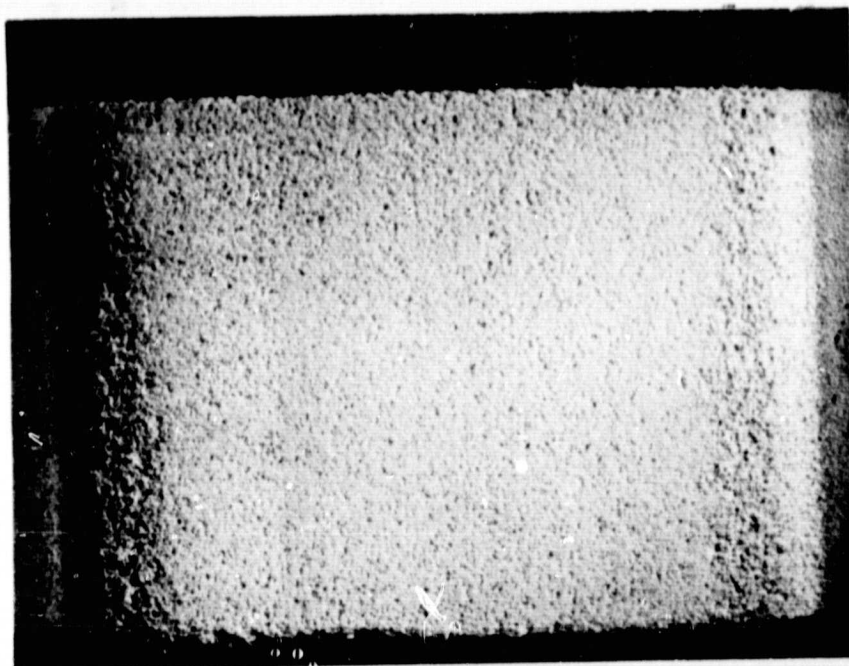
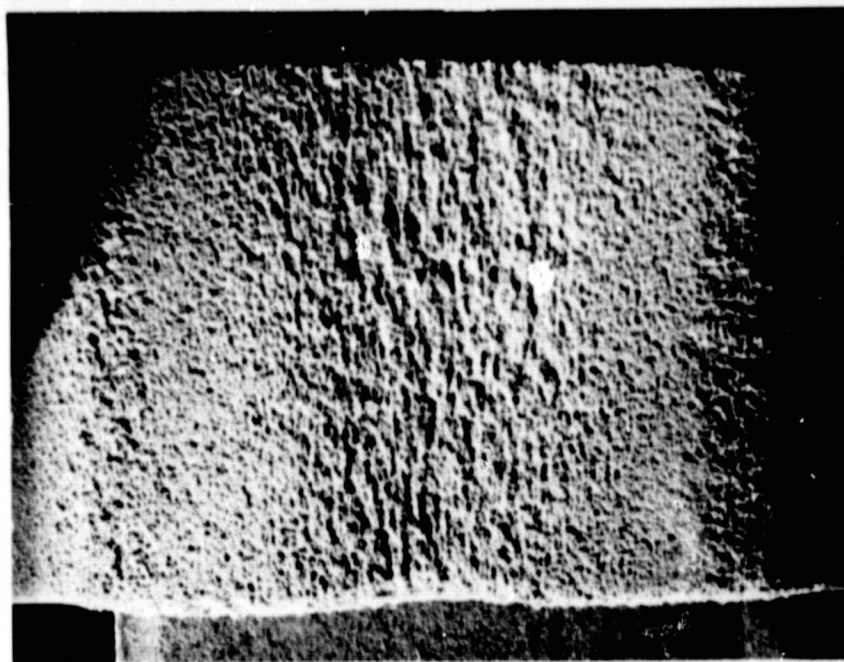
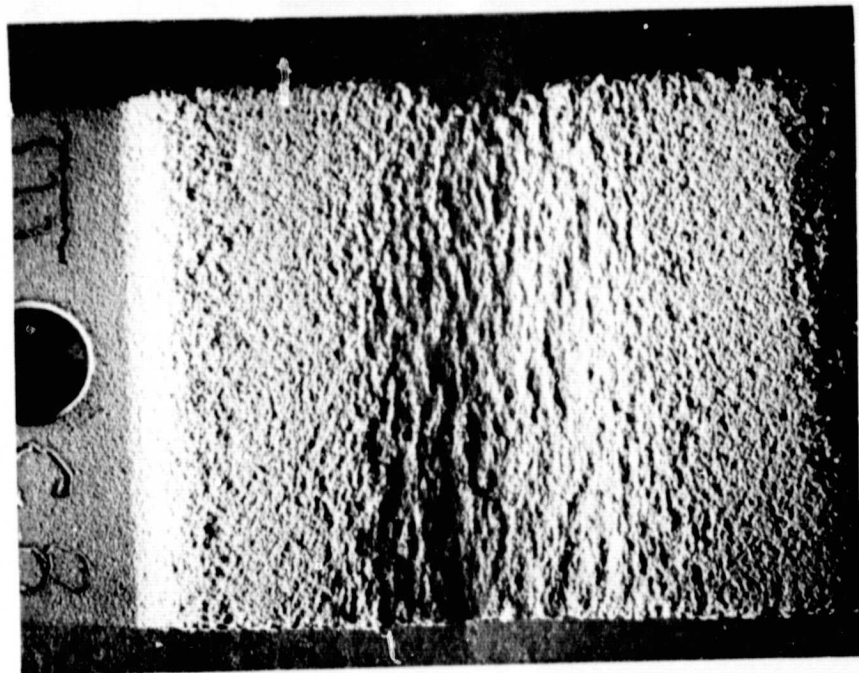
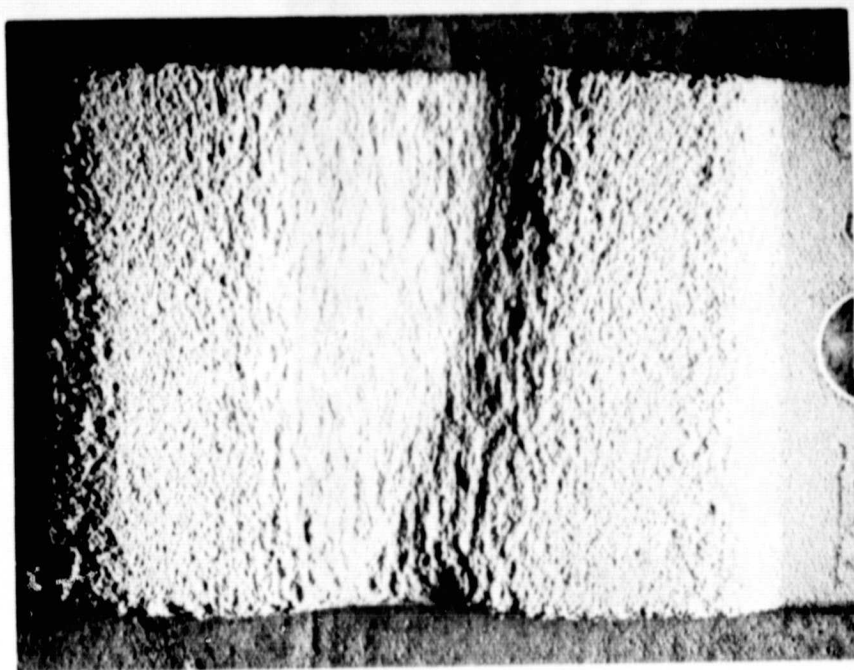
a. As machined

b. 30 min. exposure (16.4 gm abrasive)

Figure 24 Development of accelerated erosion wear scar with time for coating system III-C Magn: 3X

c. 60 min. exposure (33.3 gm abrasive)

d. 120 min. exposure (63.1 gm abrasive)

Figure 2/4 cont'd Development of accelerated erosion wear scar with time for coating system III-C Magn: 3X

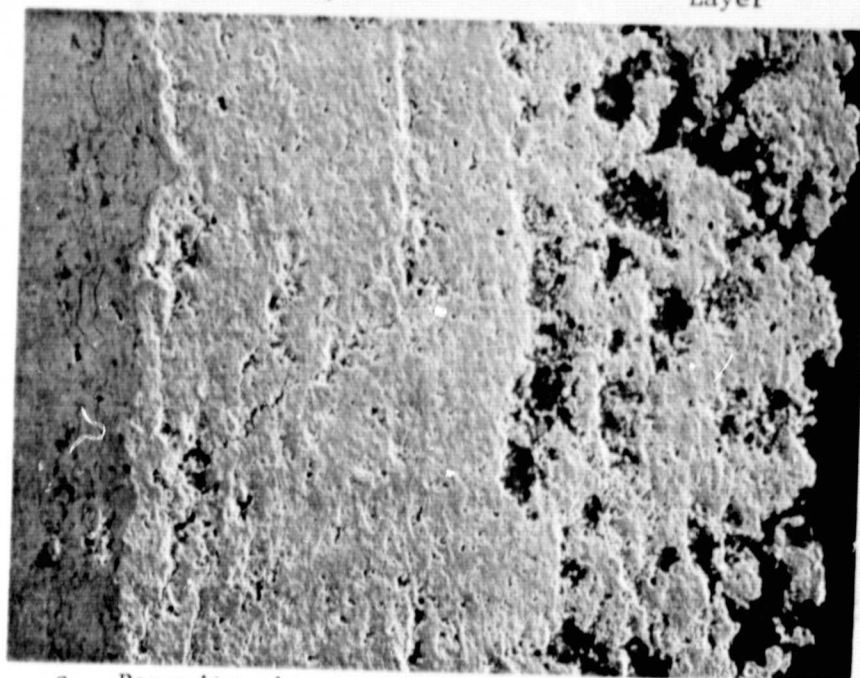
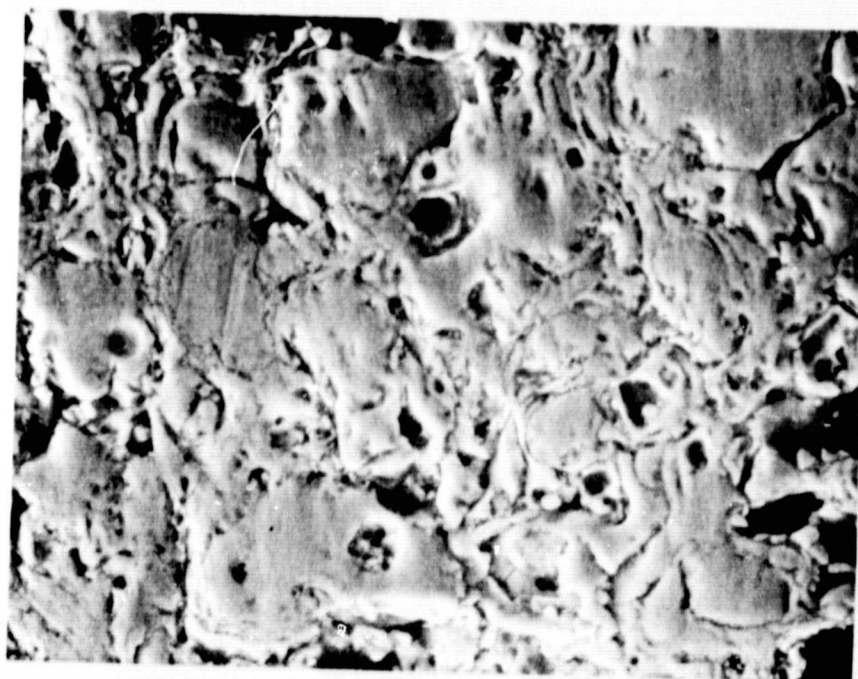
Bond Coat	Standard Density Layer	Porous Oxide Layer
--------------	------------------------------	--------------------------

a. Porosity characteristics

b. Ceramic particle morphology (outer layer)

The porosity level of the specimens I-P, II-P, and III-P were measured and tabulated in Table IV. Section views of the I-P, II-P, and III-P coatings (100X) are displayed in Figure 25a, Figure 26a, and Figure 27a. The progression of the iterations I-P, II-P and III-P leading to lower porosity levels shows that both the pore size and pore distribution decreased in subsequent iterations. It may be noted that the thickness of the porous oxide layer, as shown in Figure 25a, is inconsistent with the thickness shown in Figure 1b. This resulted from sectioning the coating at the end of the specimen, where the outer layer spray pattern tapered slightly toward the substrate.

Cross-section views at 1000X of I-P, II-P, and III-P are shown in Figure 25b, Figure 26b, and Figure 27b. The views shown display the coating fine structure resulting from plasma spray co-deposition of the polyester and YSZ powders followed by the burn-out of the polyester phase. The level of polyester powder in the plasma spray operation affects the coating structure. Particles of polyester are trapped to form voids and provide a foreign material to weaken the mechanical bonding between the deposited ceramic YSZ particles. Figure 25b, showing the porous oxide layer of specimen series I-P, shows evidence of a spongy area surrounding some of the YSZ particles which likely lessens the inter-particle bond strength.

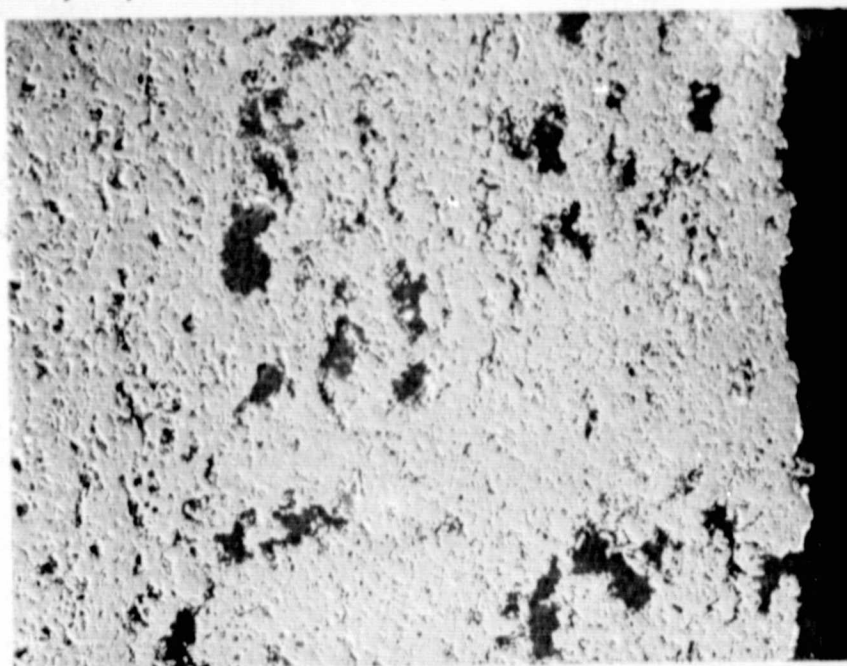
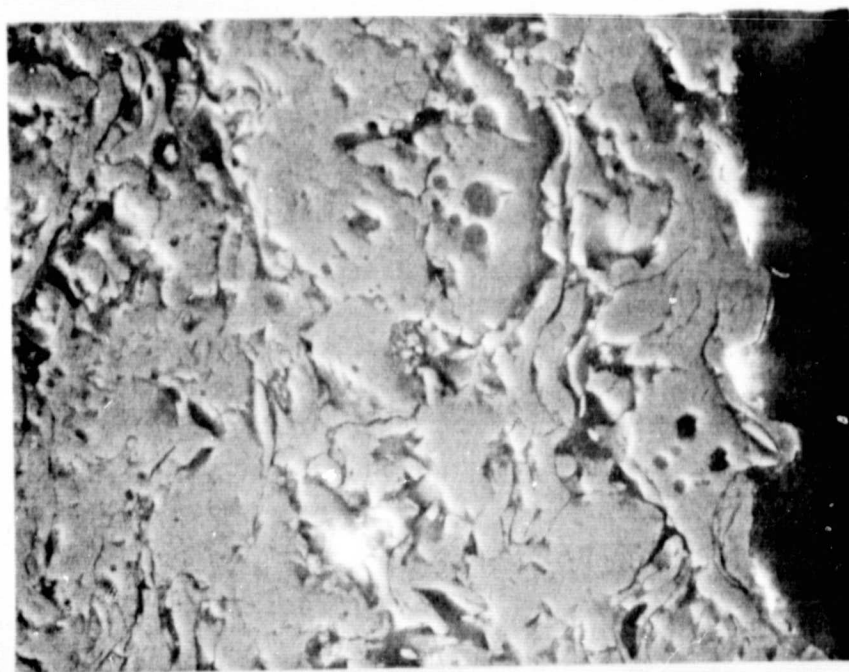
Standard
Density Layer

Porous
Oxide Layer

a. Porosity characteristics

b. Ceramic particle morphology (outer layer)

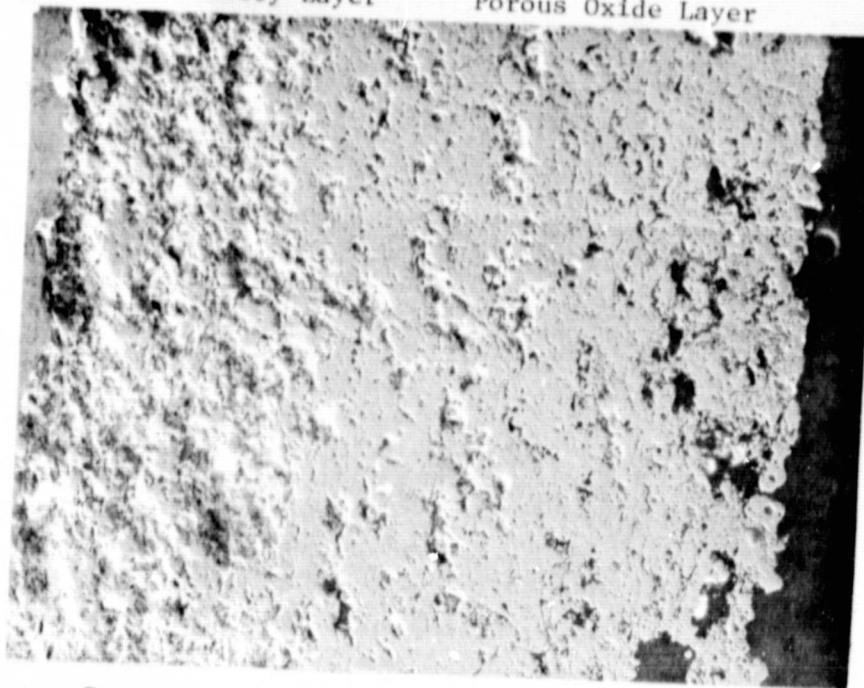
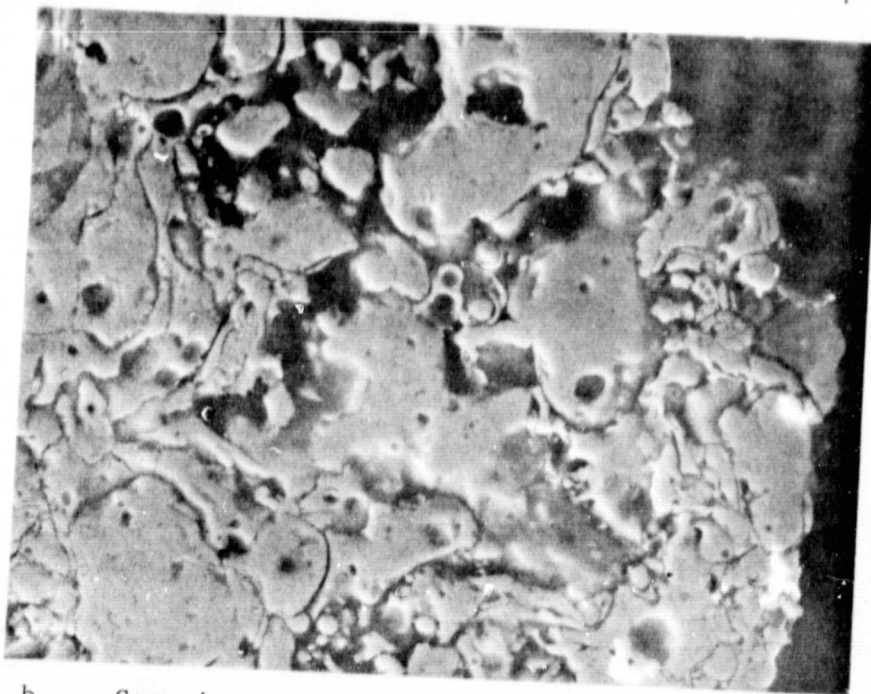
a. Porosity characteristics

b. Ceramic particle morphology (outer layer)

Figure 27 Porosity characteristics and ceramic particle morphology of coating system III-P.

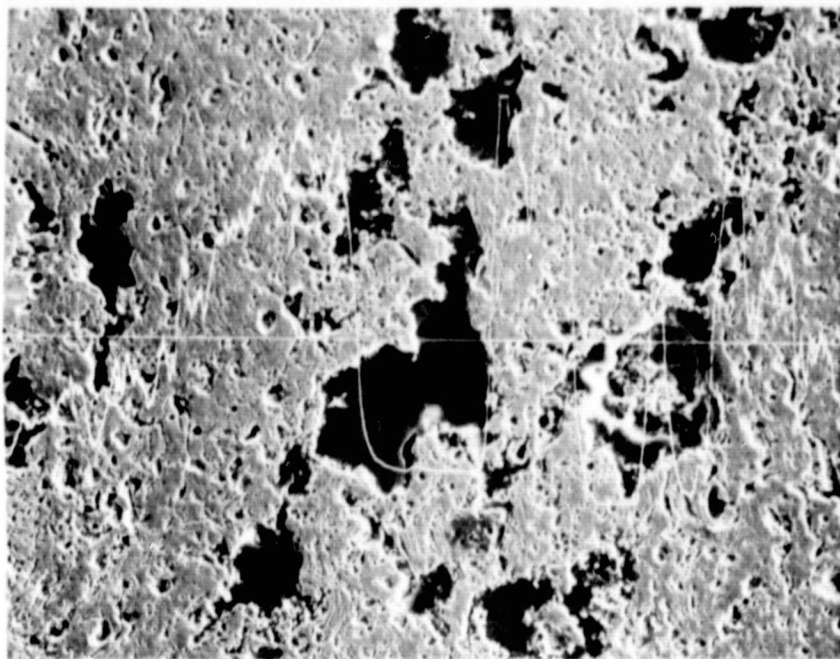
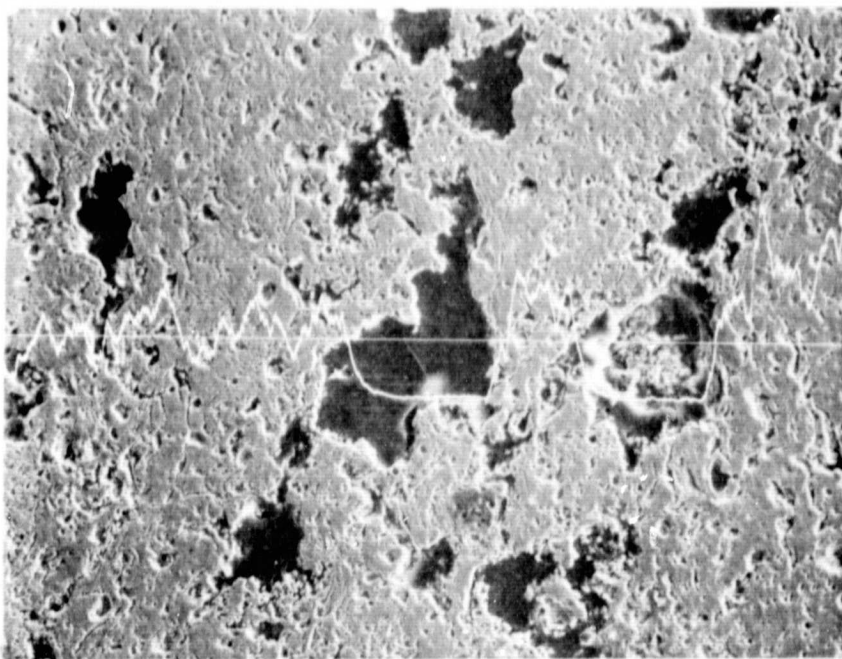
a. Elemental zirconium analysis

b. Elemental yttrium analysis

Figure 28 Elemental line scan analysis of coating system II-P
Magn: 200X

A specimen from series II-P was examined by Scanning Electron Microscopy (SEM) at 200X. Figure 28 discloses that the voids resulting from the polyester deposition and burn-out are only randomly connected and rarely

communicate between pores over a path exceeding .013-.020 cm (.005-.008 inches). The "closed pore" structure therefore explains the low permeability of the polyester/YSZ coating series compared to the leaky characteristics of abradable materials such as the sintered metal type of coating structure.

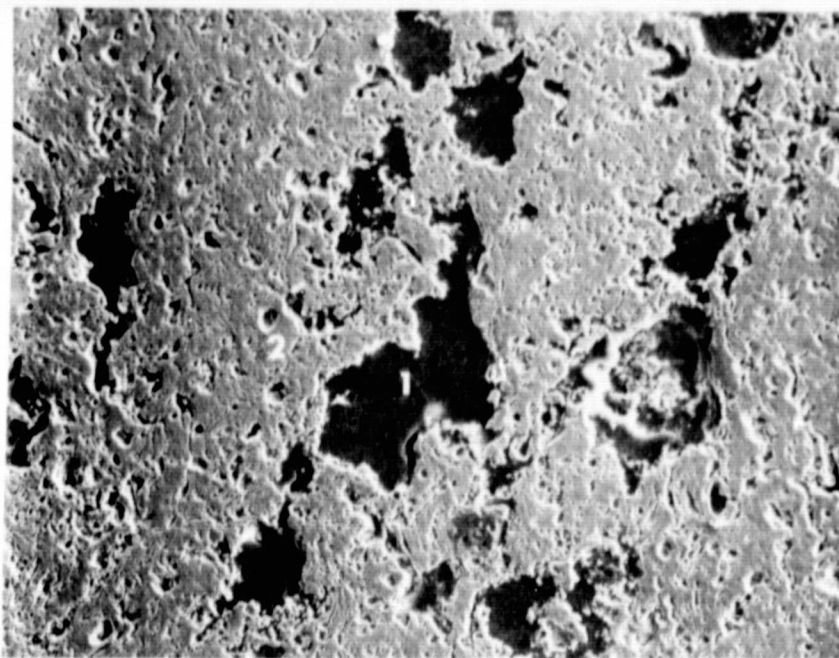
Mapped Zone Designation

Zone 1	Zone 2
Void area	Major: Zr Minor: Y, Hf Trace: Ca, Na, Si

Figure 29 displays the results of an X-ray analysis of elemental distribution on the surface of the cross section of a II-P specimen. Zone 1 is shown to be a void or surface hole. Zone 2 shows the polished YSZ surface with a major indication for zirconium and a minor indication for yttrium. Minor traces of calcium, silicon and sodium were also noted.

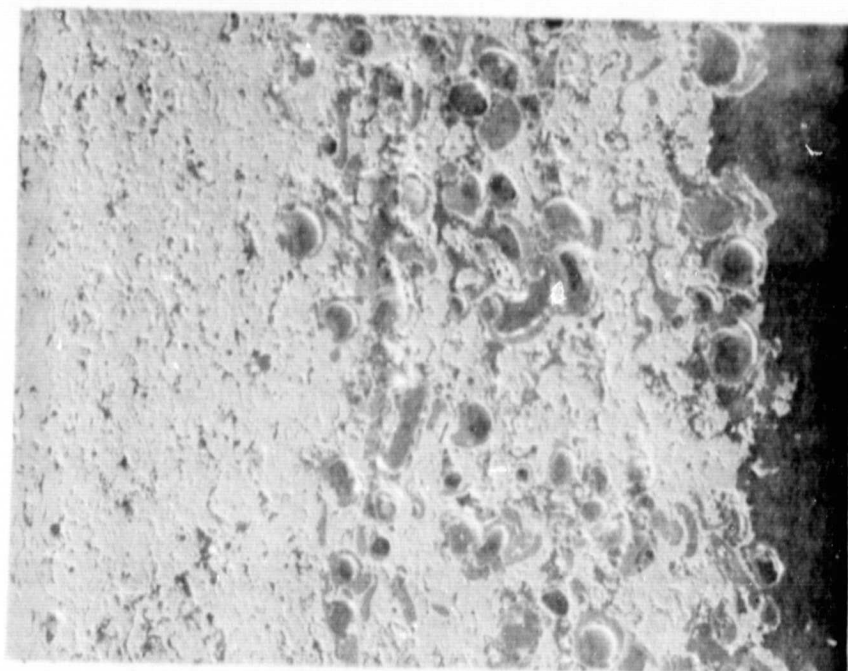
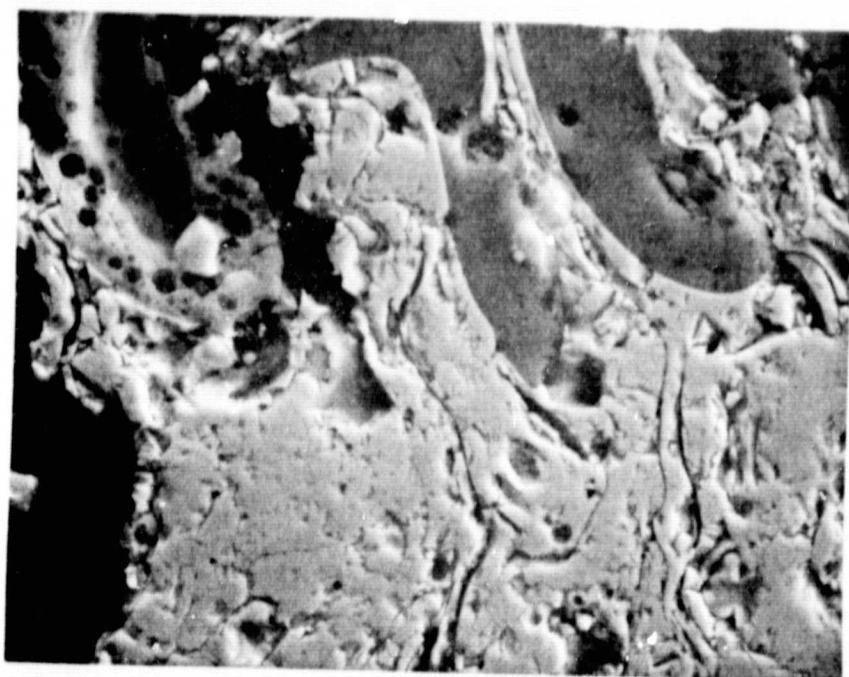
a. Porosity characteristics

b. Ceramic particle morphology (Outer layer)

Figure 30 Porosity characteristics and ceramic particle morphology of coating system I-C

The porosity level of the test specimen series I-C, II-C, and III-C is achieved by the in-situ trapping of the hollow cenospheres during plasma spray co-deposition with the YSZ ceramic material. Section views of specimens from the series in I-C, II-C and III-C coatings are displayed in Figure 30a, Figure 31a, and Figure 32a. The progression of the iterations of the I-C, II-C and III-C series was to increase the cenosphere percentage with a goal of improving abrasability. The level of cenosphere entrapment was measured by a point-count technique and found to be 30, 35 and 32 volume percent respectively for I-C, II-C, and III-C as shown in Table IV.

Cross-section views at 100X of series I-C, II-C, and III-C are shown in Figure 30b, Figure 31b, and Figure 32b. The high magnification reveals that the yttria-stabilized zirconia coating matrix encloses both identifiable whole cenosphere particles and solidified agglomerates of the cenosphere material. The solidified agglomerates appear as fairly smooth glassy type particles with little evidence of fracture through the phase. In contrast, the zirconia matrix exhibits both irregular voids and crack or internal fracture patterns.

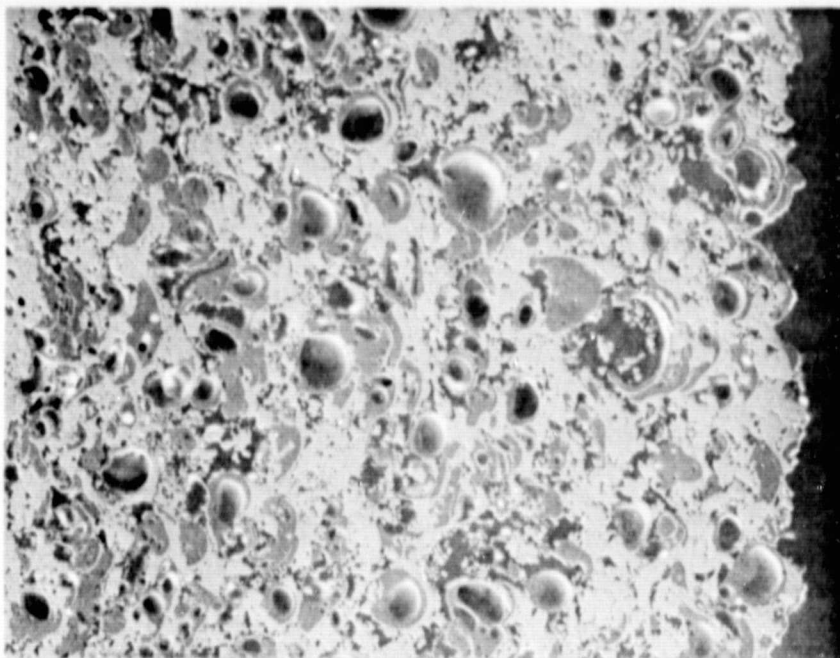
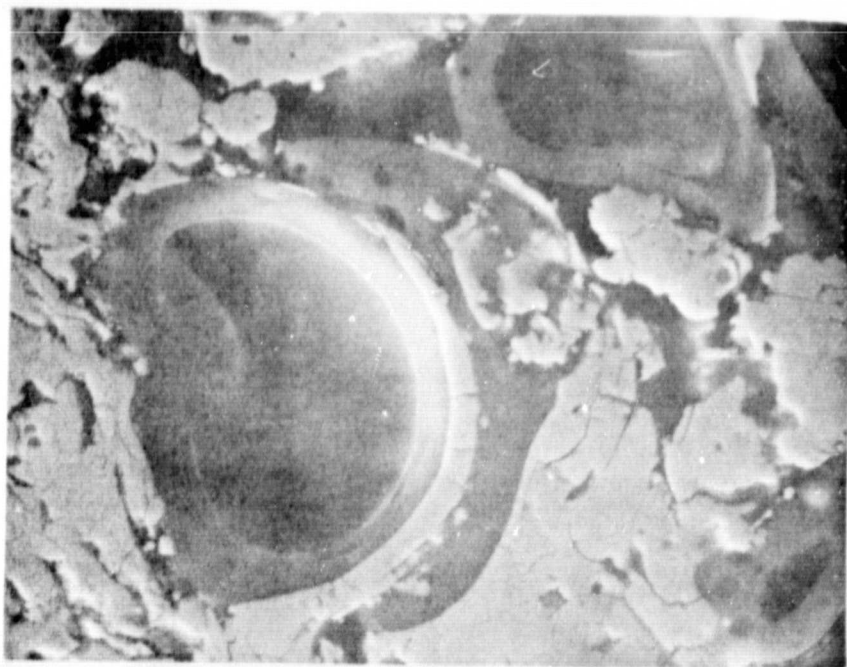
a. Porosity characteristics

b. Ceramic particle morphology (outer layer)

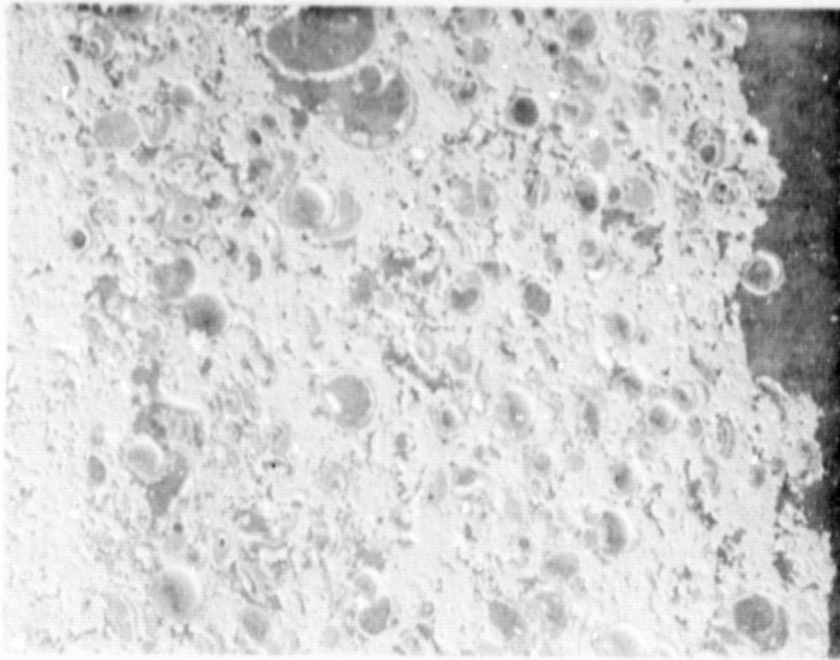
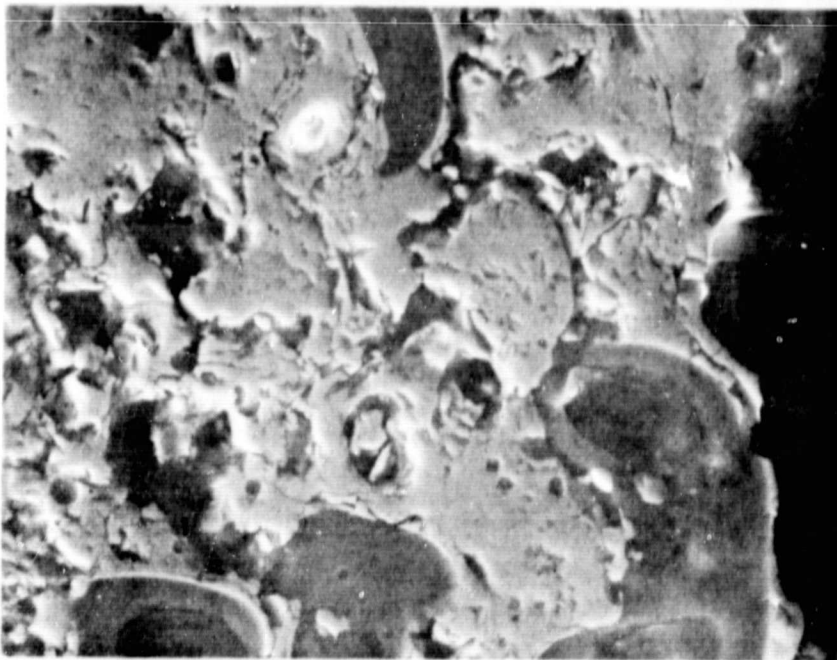
a. Porosity characteristics

b. Ceramic particle morphology (outer layer)

Figure 32 Porosity characteristics and ceramic particle morphology of coating system III-C

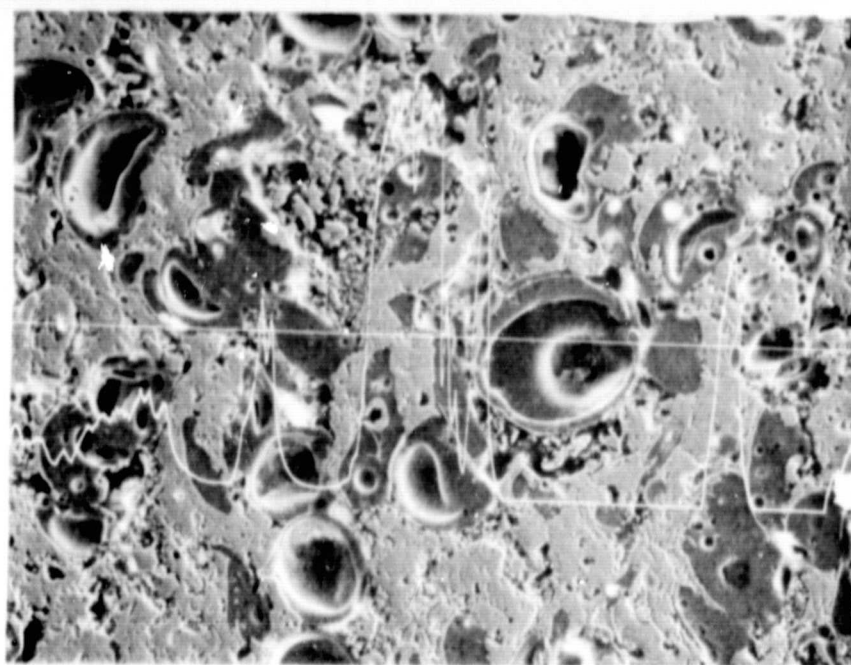
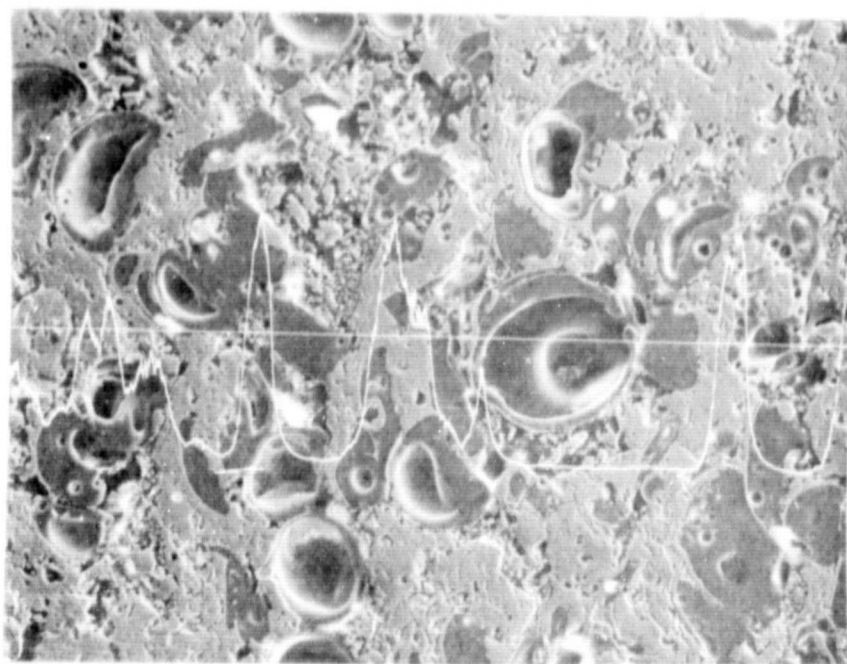
a. Elemental zirconium analysis

b. Elemental yttrium analysis

Figure 33 Elemental line scan analysis of coating system I-C Magn: 200X
